Titanic's First 15 Minutes After the Collision: Jumping to Conclusions

by Roy Mengot

Abstract

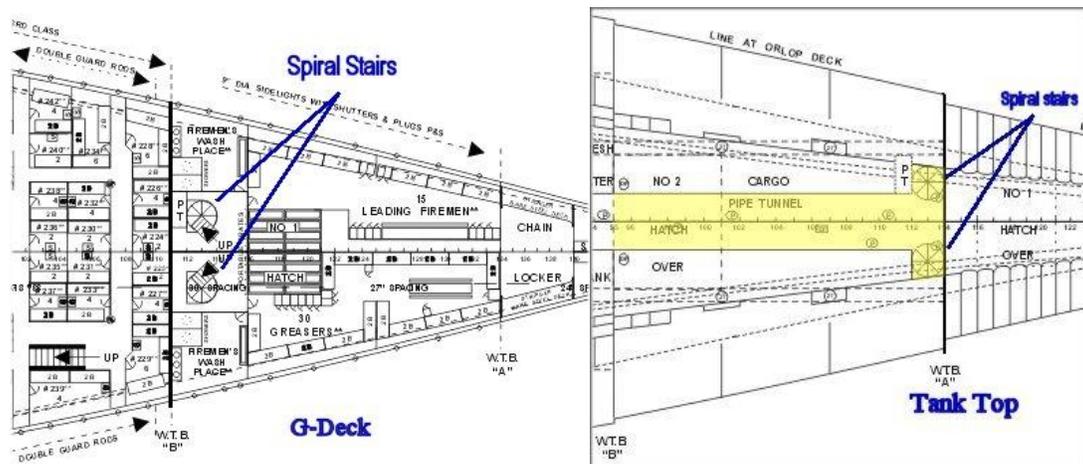
2. Watertight bulkhead B between #1 hold and #2 hold went up to G-deck, a couple of feet above the waterline, but jogged aft to allow the spiral staircase to cross through the bulkhead. The firemen's passage continues aft through holds #2 and 3, but is watertight except for the access from #1 hold. At G-deck, there are simple doors separating the spiral staircase from the quarters for the lead firemen and the greasers adjacent to the #1 hatch. The #1 hatchway is walled at the sides and front, but the aft side of the hatchway is covered only by a steel gate.

Figure 1: G-Deck crew quarters were in #1 hold watertight compartment. The pipe tunnel on the tank top was built to be part of the #1 hold compartment and was watertight from #2 and #3 holds as it passed through them. (Bruce Beveridge drawings)
